Contactor

Information for electrical contractors, architects and consulting engineers

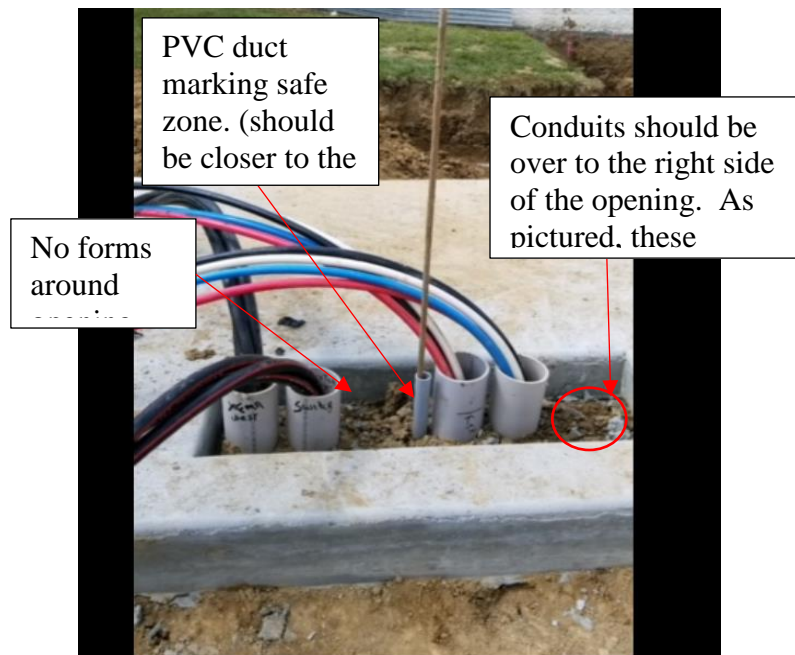
Additionally, the contractor should be removing slab forms once concrete is set. Failure to do so is pushing conduit towards the middle of the slab opening and outside the areas laid out in the slab drawings. Conduits should be installed as far to the right in the slab opening as possible as directed in the transformer slab drawings. That better enables the secondary conductors to be terminated.

Below is a picture to illustrate the instructions above. As noted, there are some things that should be different.

In an effort to avoid damaging conduit while installing a ground rod, OPPD is requiring the contractor to mark an area on the primary side of the transformer where installing the 8' ground rod will not run into any conduit installed below. It is suggested a small section of conduit identified as a ground location be placed in the ground showing the "safe zone". OPPD is not responsible for damage during ground rod installation if no marking is present. The safe zone should be approximately where the ground rod is shown on the slab details from the meter specification manual.
